REMOVAL ASSESSMENT CHECKLIST

**PHOTO DOCUMENTATION
MILLIPORE CIDRA, INC., ON-SITE RECONNAISSANCE
APRIL 2002 and DECEMBER 2004**

**PHOTOGRAPHIC LOG
MILLIPORE CIDRA, INC.
CIDRA, PUERTO RICO**

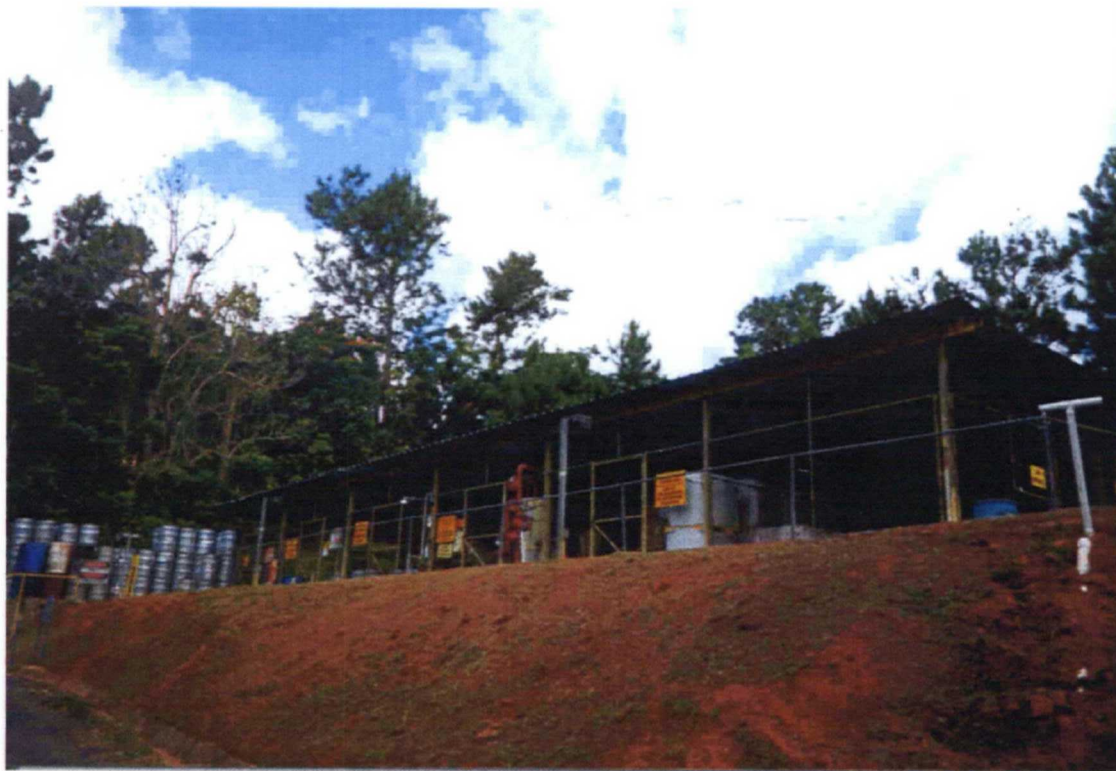
Photo 1. View of the northwest side of the waste storage area.

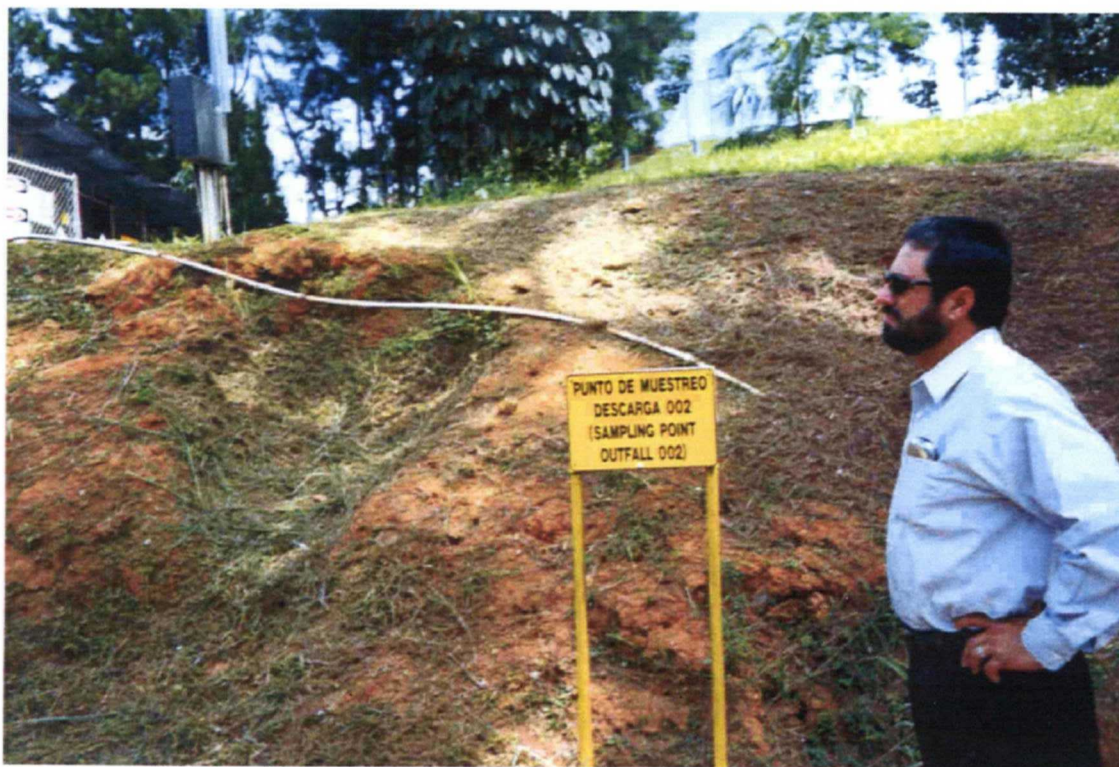
Photo 2. Discharge point area .

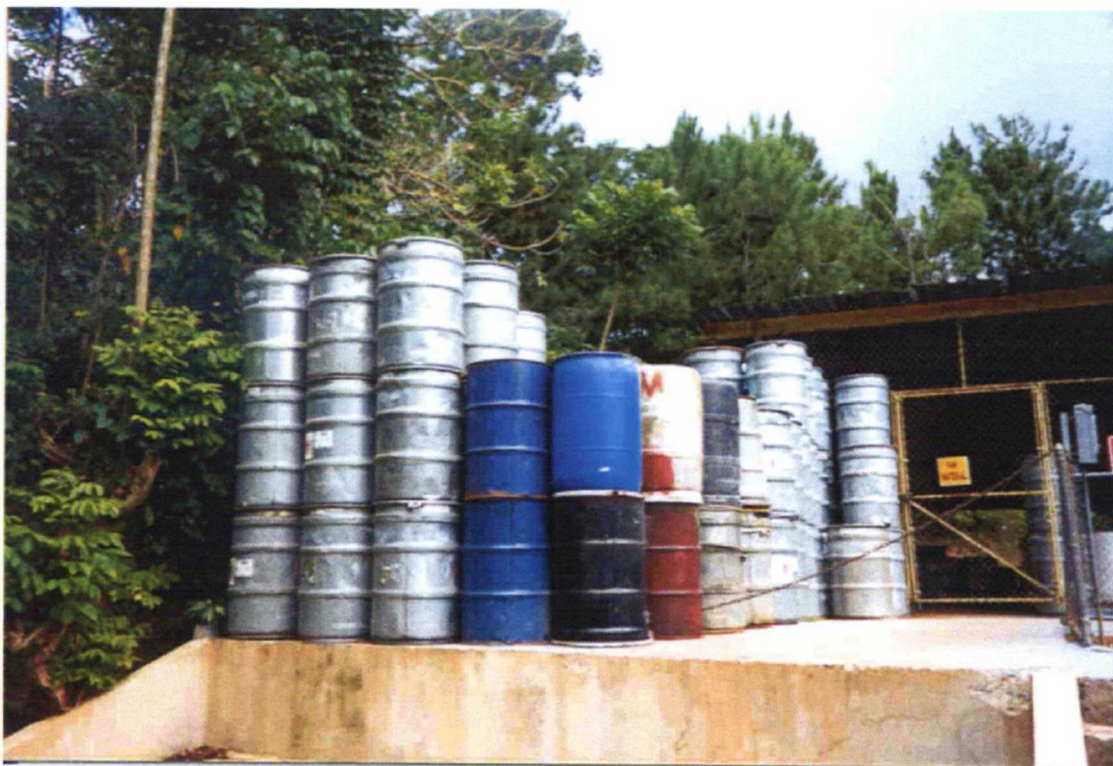
Photo 3. Empty metal and plastic 55-gallon drums in the north side of the waste storage area.

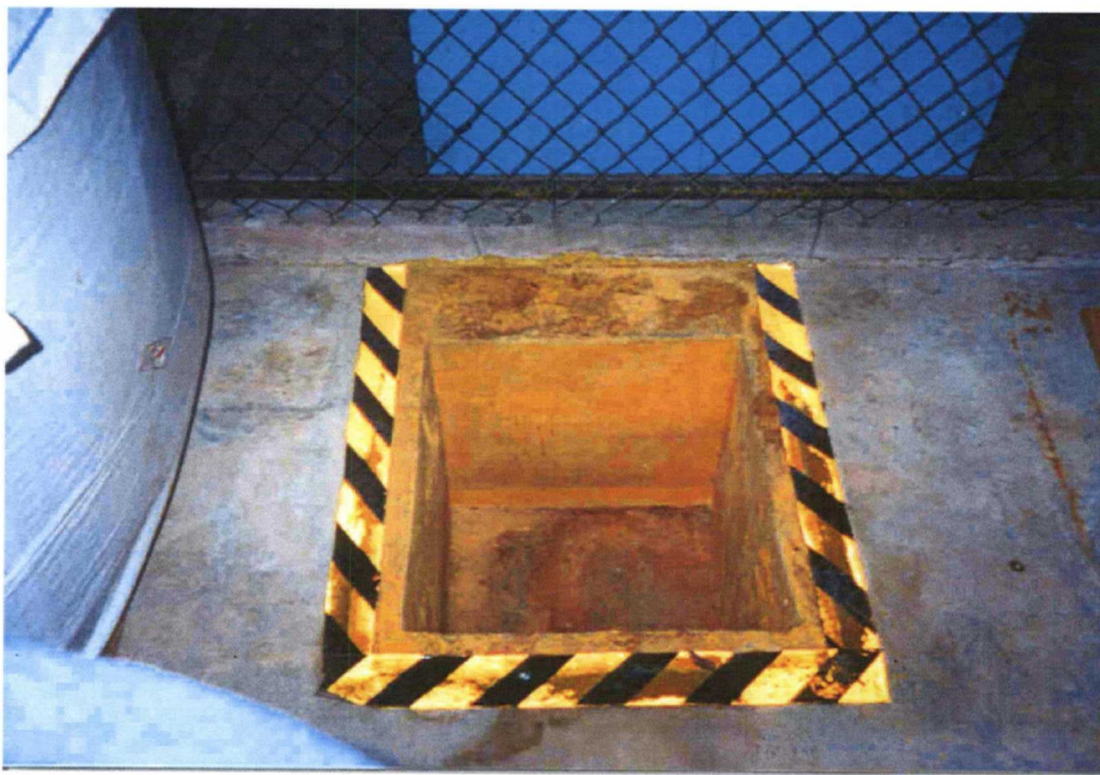
Photo 4. Sump/pit in the waste storage area.

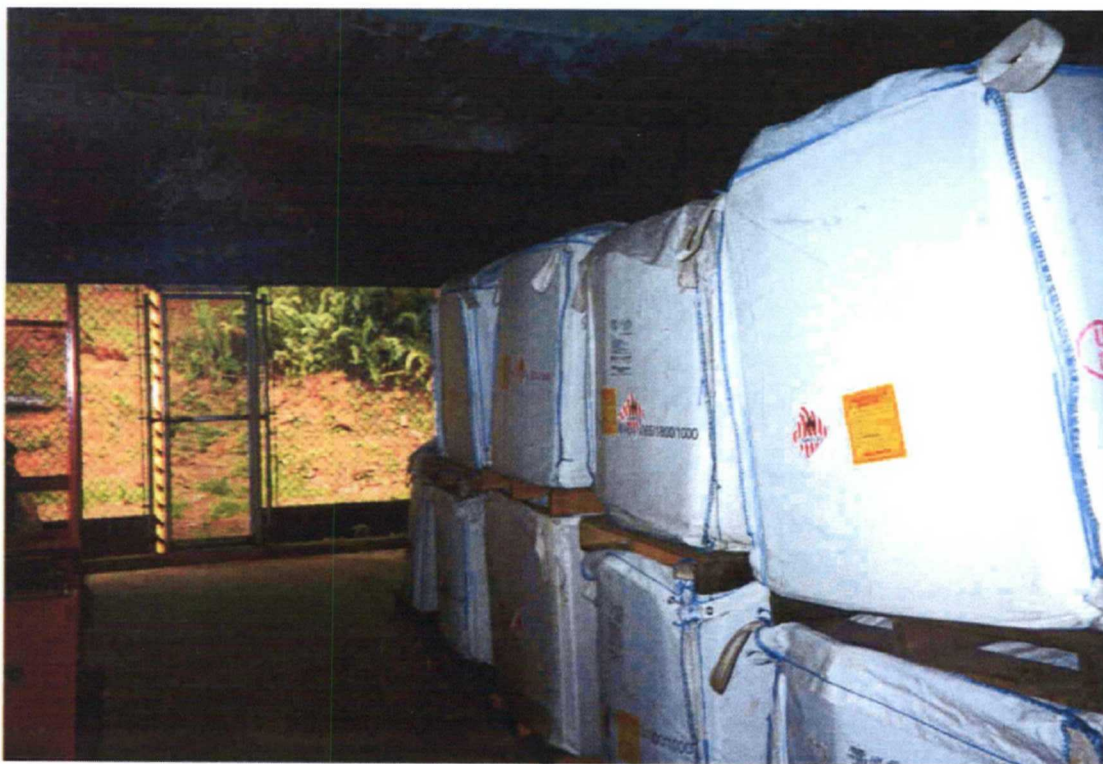
Photo 5. Pallets of dry waste in the waste storage area.

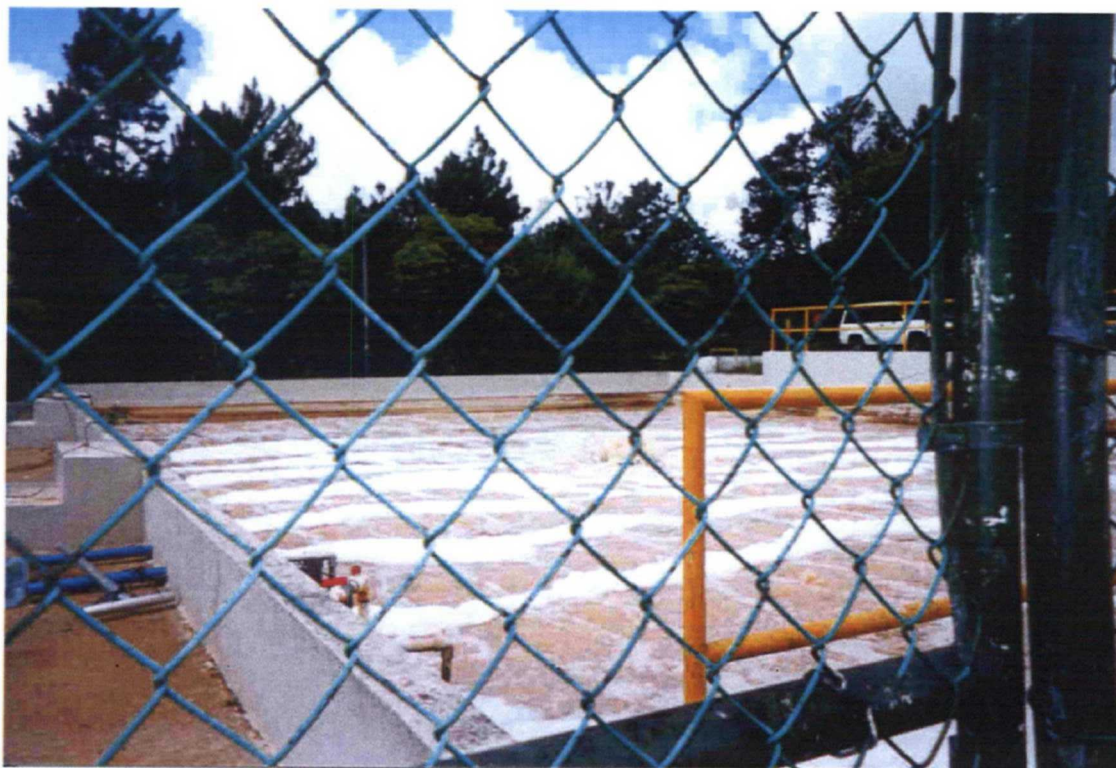
Photo 6. Aeration pond part of Millipore's wastewater treatment plant.

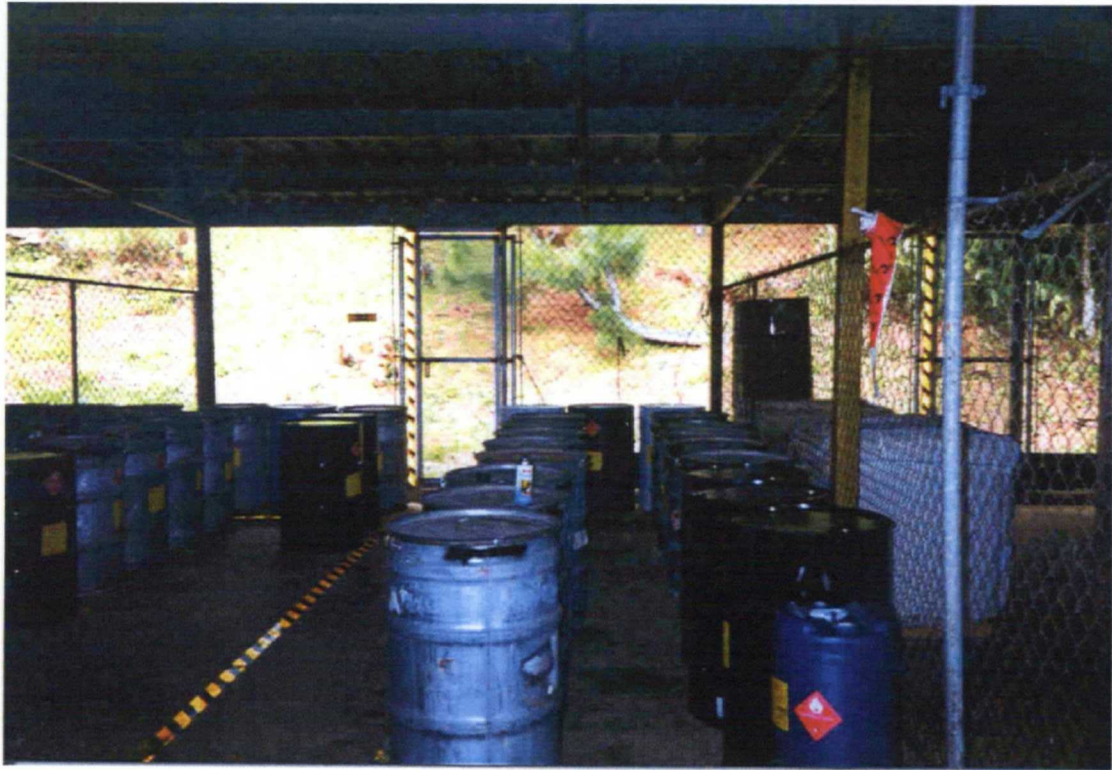
Photo 7. Liquid wastes stored inside the waste storage area.

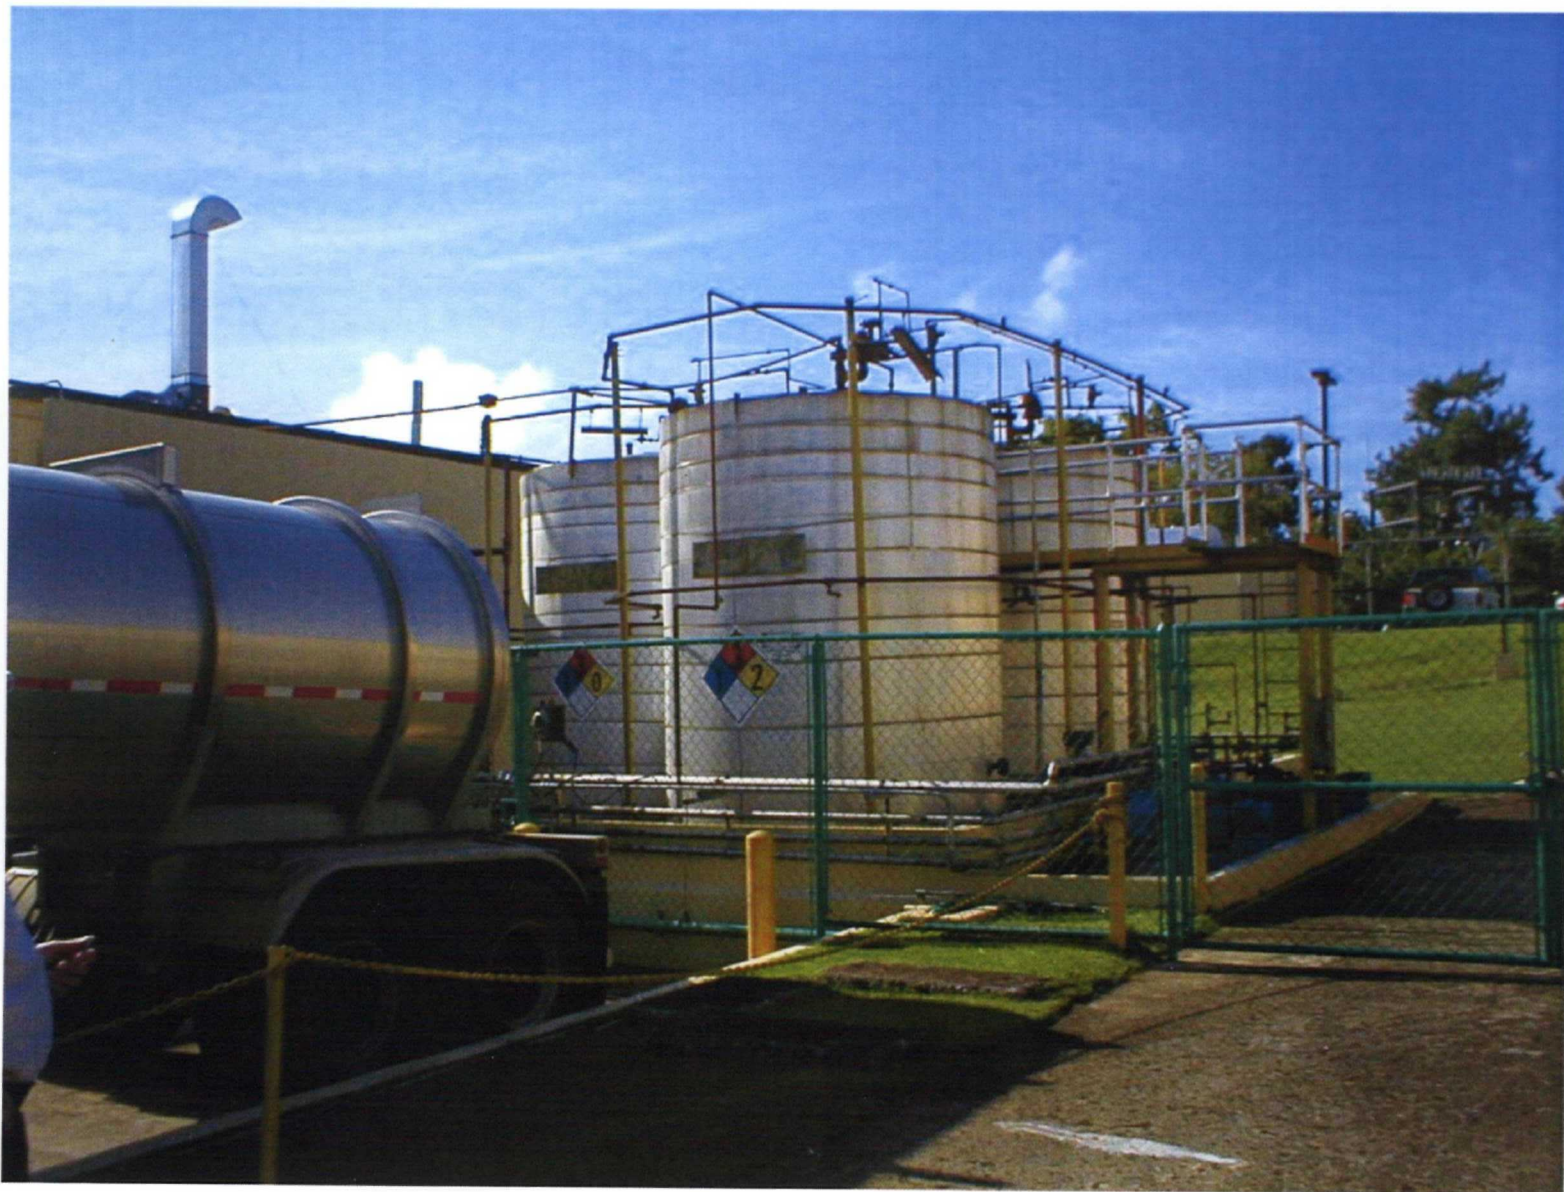
Photo No. 12-20-01: Solvent storage tanks (raw material); looking SE, 0935 hours.

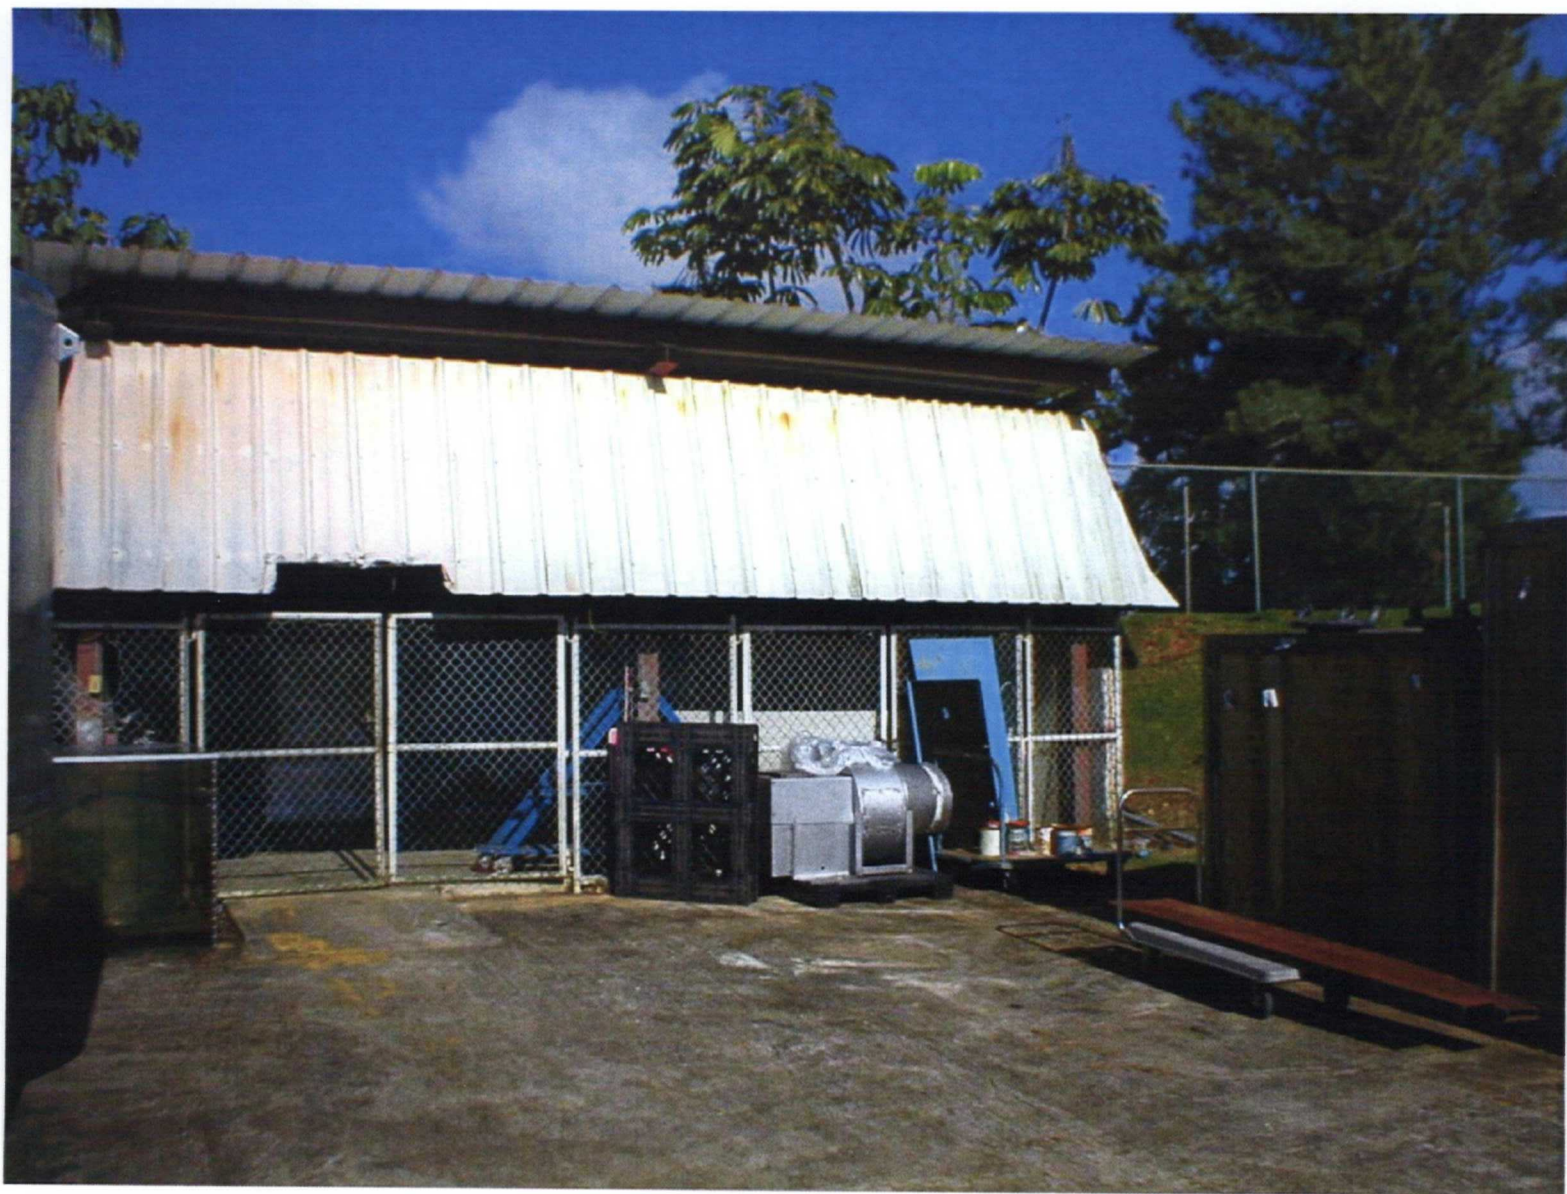
Photo No. 12-20-02: Former hazardous waste storage area (HWSA); looking N, 0940 hours.

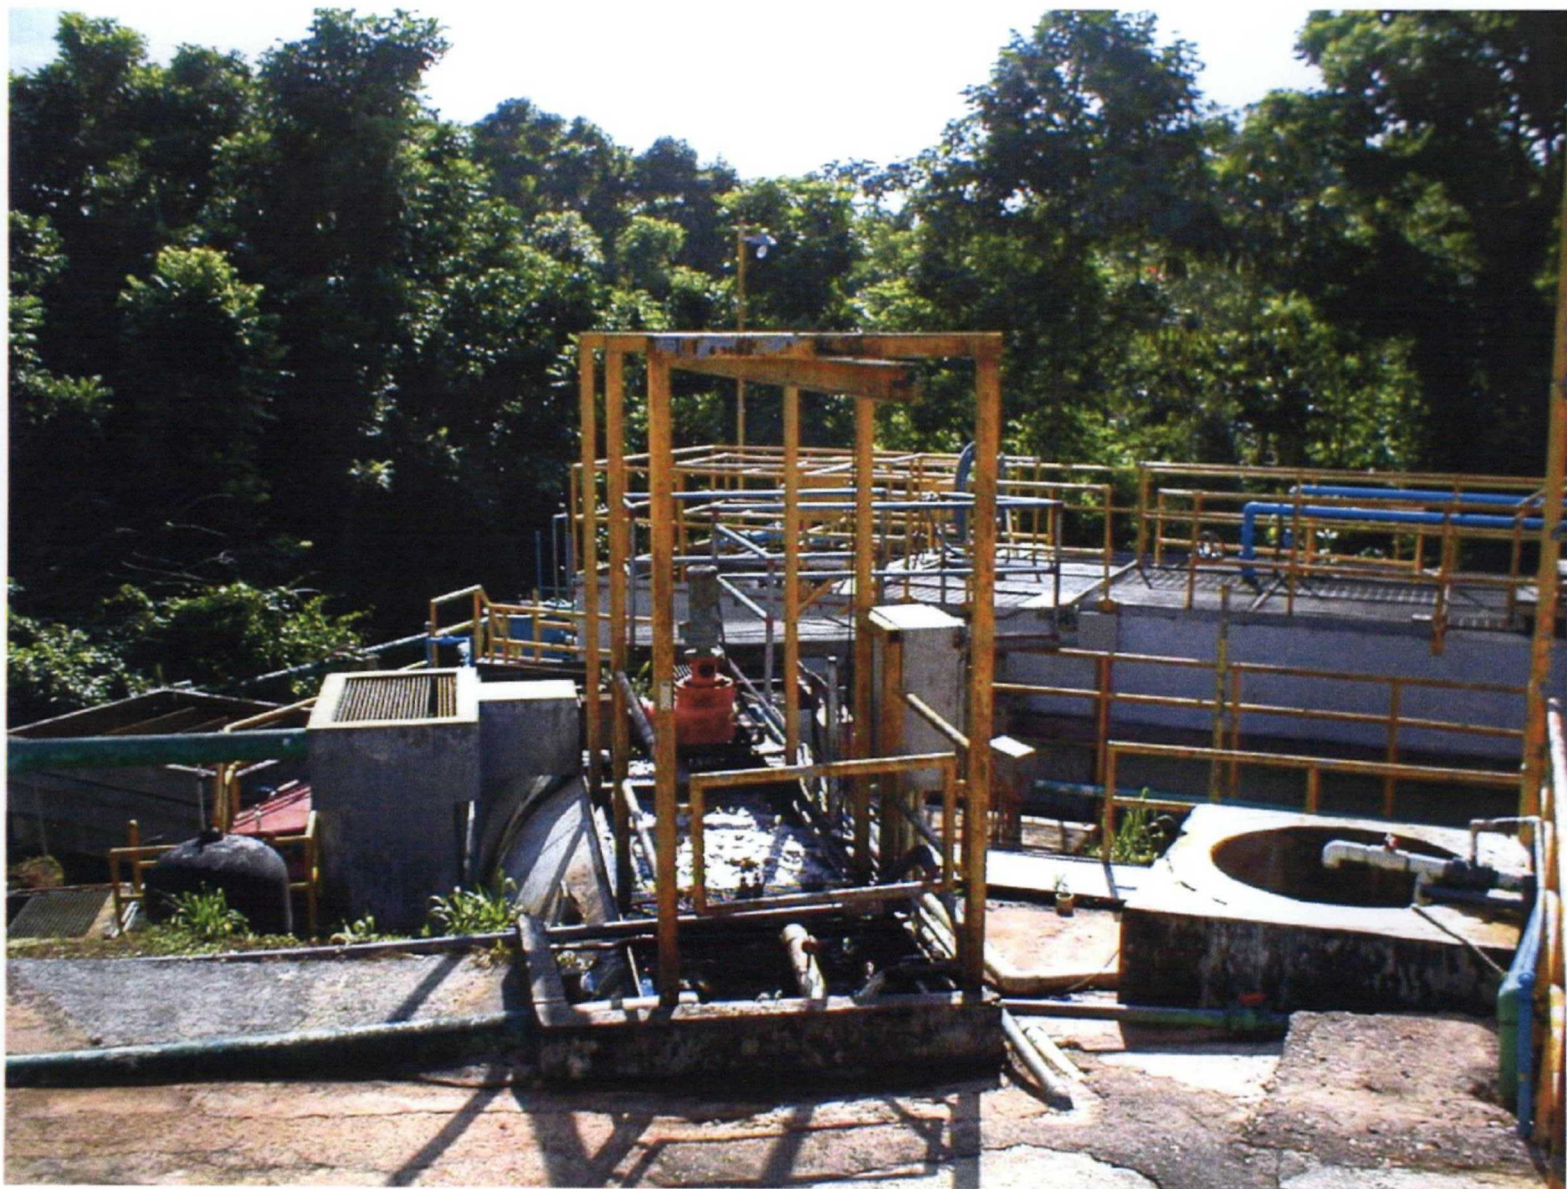
The solid waste storage area was found to be clean and well maintained. The concrete pad is roofed, fenced, and surrounded by curbing to contain spills. Runoff is routed away from the storage area through spillways and pipes. During the December 2004 on-site reconnaissance, the WWTP appeared to be operating normally. No leachate was observed in the vicinity of the active leachfield.

Photo No. 12-20-04: Wastewater treatment plant (WWTP); looking S, 1005 hours.

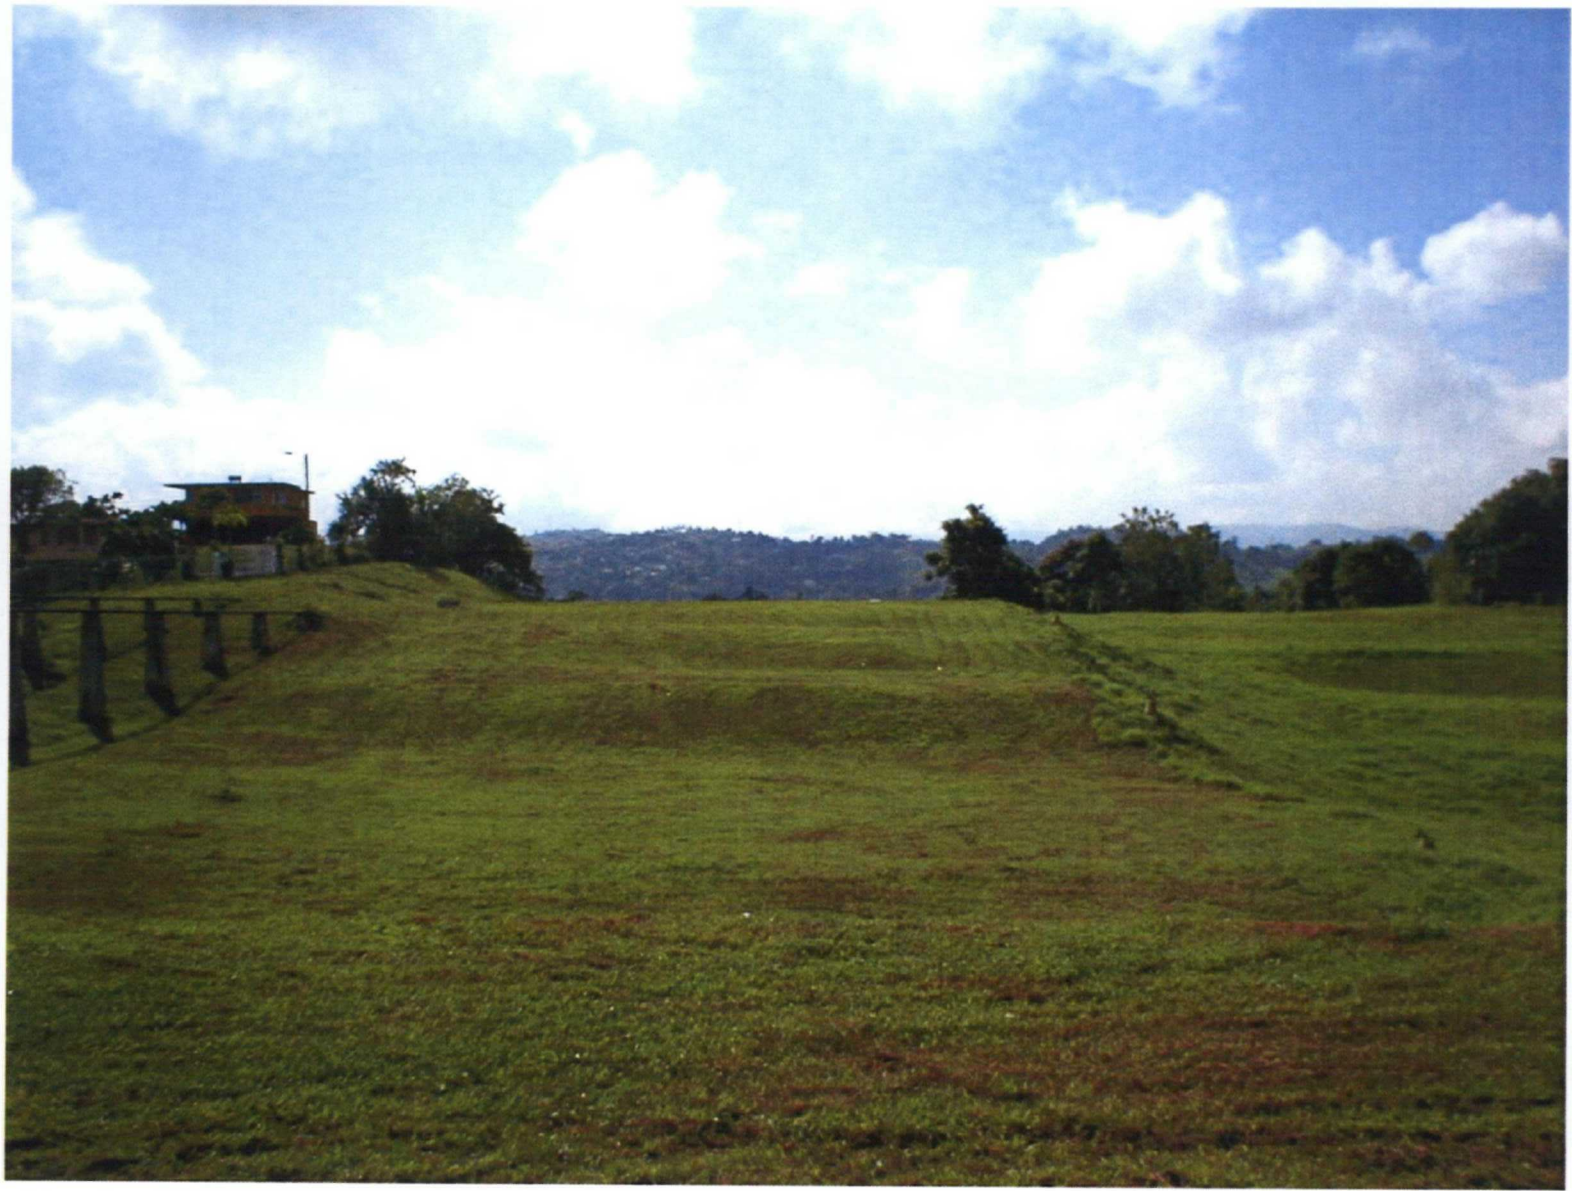
Photo No. 12-20-08: Wastewater treatment plant (WWTP) leach field; looking S, 1050 hours.
